Technical Note N-859

CORROSION RATES OF SELECTED ALLOYS IN THE DEEP OCEAN

J. B. Crilly and W. S. Haynes, Ph. D.

17 November 1966

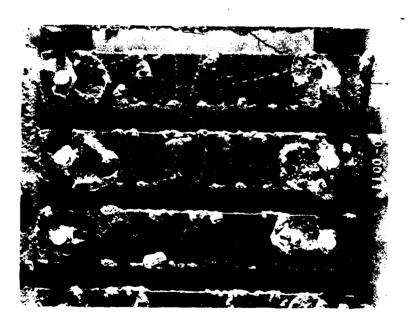
Figure 6. Sample 69, Aluminum 1100-0; QQ-A-561

Of the sixteen remaining sets of metals, the corrosion rates and appearance of all specimens of a set were in good agreement -- corrosion rates for all members of thirteen of these sets falling within ten percent of the arithmetic mean. All test specimens of three of these metals corroded at a rate less than 1.0 MDD: aluminum 5052-H22, aluminum bronze, and lead. Aluminum Alclad 7075-0 and phosphor bronze corroded at rates of 2.0 MDD and just above. In the aluminum Alclad there was no pitting or other localized corrosion, but the corrosion of the aluminum 5052-H22, to the extent occurring, was concentrated mostly under the nylon bolt heads with a little damage on the cut edges. The aluminum bronze showed very slight corrosion in tiny spots. A thin film of corrosion products formed on the phosphor bronze specimens, and some scale. The lead samples had a thin blue adherent film with no damage underneath. Seven of the remaining sets corroded at rates between 3.0 and 4.0 MDD, and samples of commercial brass at rates from 4.0 to 5.6. In the latter case the only visible evidence of corrosion was a slight surface staining. The seven sets, together with descriptions, were: wrought iron, with uniform corrosion (no pitting); electrolytic copper, small tubercules and some streaking corrosion products with slight scaling; yellow brass, with slight surface staining only; both sets of the aluminum 3003 showing severe crevice corrosion from the cut edges; aluminum 1100-0 samples severely pitting and with crevice corrosion

around the nylon bolt heads; and, aluminum 2024-T3, with some surface pitting, some corrosion under the nylon bolt heads, and severe crevice corrosion resulting in a layered structure. Samples of the last three sets corroded at rates between 5.0 and 6.0 MDD: aluminum 7178-0, with severe pitting spreading to sizeable areas in some cases to perforation; bronze, with many small tubercules, and larger ones evident about some of the nylon bolt heads; and, naval brass, which did not appear seriously corroded in spite of the high corrosion rates, suggesting dezincification.

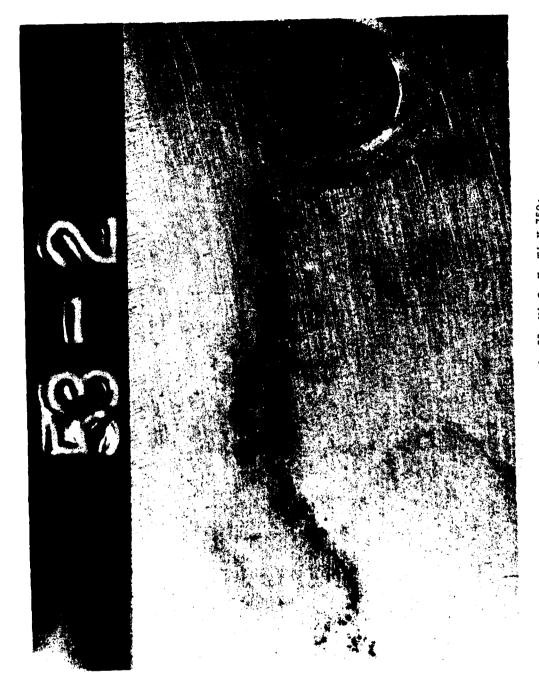
Figure 18. Sample 53, Ni-Cr-Fe-Ti X-750; AMS-5542-D

Alloy	Sample No.	Corrosion Loss, MDD*	Corrosion Rate, MPY**
Ni-Cr-Fe-Ti X-750	S-53-1	0.01	0.00
	S-53-2	1.2	0.21
	s-53-3	0.01	0.00
	s-53-4	0.06	0.01
	s-53-5	2.1	0.37
Two of the specimens corrod neath the metal surface; overall concentrated where it does occur gible corrosion. On specimens 5 47 mils; average of ten deepest	loss not g Other th 3-2 and 53-	reat but effe ree specimens 5, deepest pi	ct is quite show negli- t was 36 and
Ni-Cr-Fe-Ti 600, Cond. A	S-54-1	0.01	0.00
